# Interagency Aviation SAFETY ALERT

No. IASA 21- 06

**Subject:** “Klump Pump” or “Smart Pump” External Load

**Area of Concern:** Helicopter External Load Operations

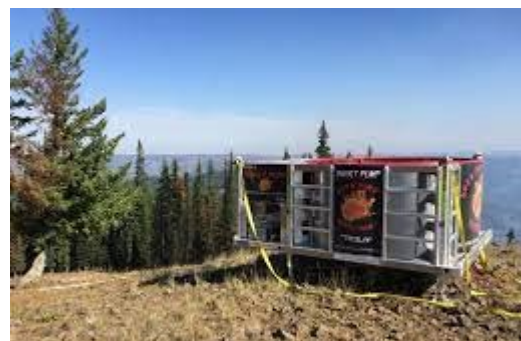
A “Smart Pump” is a 300 to 1700-gal IA/Mop-up tank that can be transported via helicopter external load to the fireline. The total weight of the Smart Pump and equipment is around 3,000 lbs. The Smart Pump is equipped with four contractor-provided nylon straps, each capable of supporting 3200 lbs. The straps are attached to a Gunnebo Swivel Shackle (see pictures below). Each strap is attached to the tank frame with a screw pin anchor shackle secured in place by a zip tie.

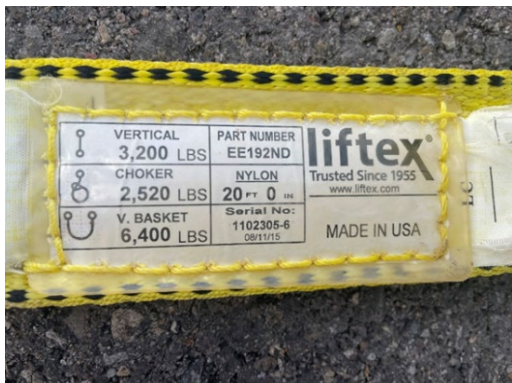
Liftex Strap Specifications

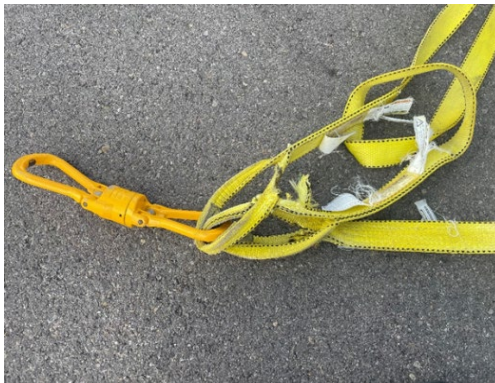
Gunnebo Swivel Shackle w/ Liftex Straps

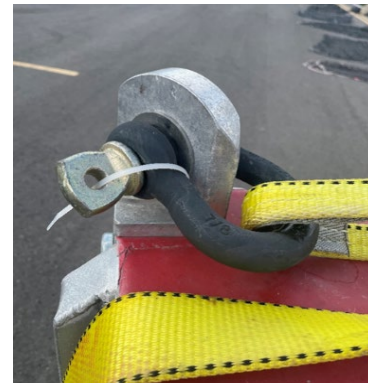
Anchor Shackle w/zip tie

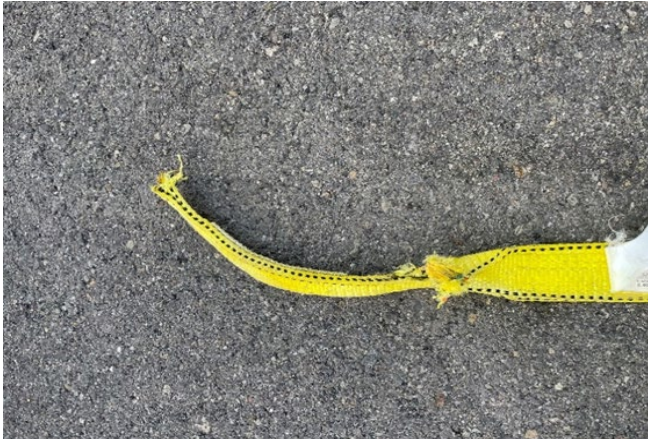
The load had been inspected prior to flight with no anomalies noted. Once the aircraft returned to the helibase, an additional inspection revealed that one of the lift straps had separated and some areas of the nylon appeared to be melted along with signs of friction and chaffing damage.

Broken Liftex Strap

- Any external load rigging for Smart Pumps should involve disconnecting all contractor provided rigging equipment and using approved lead lines and swivels to rig the load. This would consist of four lead lines and three swivels (see picture to the right).

- Prior to each use, helicopter personnel should thoroughly inspect all straps and equipment for signs of UV damage, burns, frays, or tears. This is especially important for backhaul after the Smart Pump has been exposed to heat and environmental factors on the fireline.

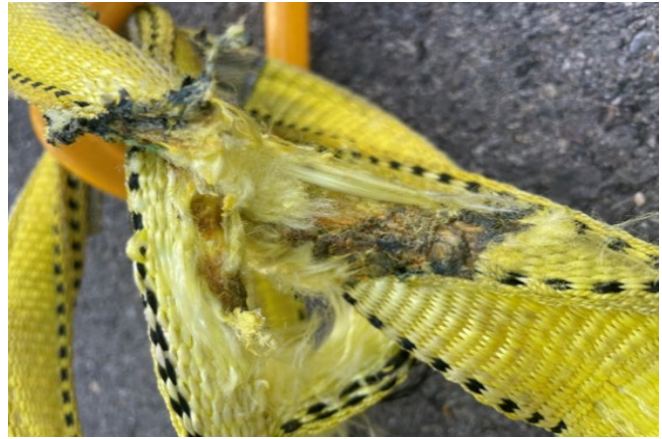
Melted Liftex Strap near Gunnebo Shackle

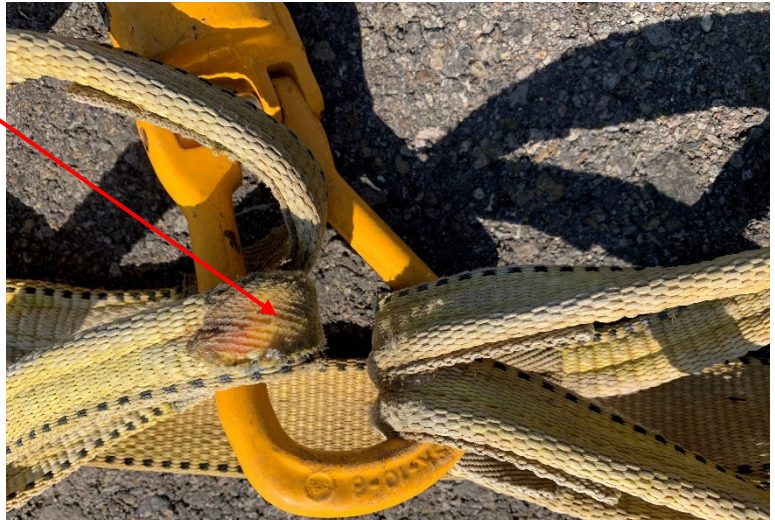
- The company has five units in service. All units are configured with the same tow strap rigging system.
- The straps have been installed on all of the units since 2015 and have no UV protection. There were obvious signs of fading and UV damage on the two units that were inspected.
- The second unit showed notable strap melting. The straps appeared to bond together at the point where they travel through the swivel.
- All the rigging equipment is provided and installed by the vendor with no oversight required by the agency.
- The company providing the Smart Pumps were hired under an Emergency Equipment Rental Agreement (EERA). No prior evaluation or approval of the equipment was completed by the agency.

Faded areas, showing UV damage to straps

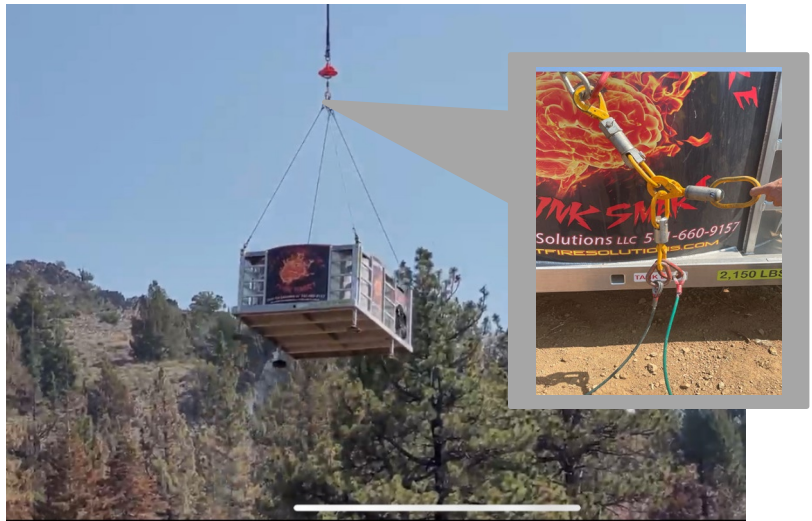
Recommended Rigging for Smart Pumps
